**Flood Control Project Maintenance  
Levee Inspections**  
**LMA District Cover Sheet**  
**Spring 2020 Levee Inspection Results**

**Sutter Maintenance Yard Hamilton Bend**

**Levee Inspection Report By Mile - Spring 2020**

Waterway	Bank	Unit Miles	Inspection Start/End	Inspector
Unit No. 01 Feather River Hamilton Bend	Right	3.39	03/18/2020 03/18/2020	Sterling York

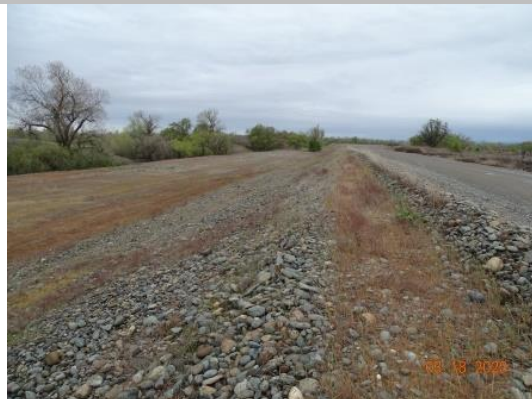
Photo 1 of 1 : SP\_2020\_ST0005\_289\_3\_20200327\_00012.jpg

LM Start	0.01	Rating **	A	Issue No.	3
LM End	1.22	Issue Type +	Ma	Location *	LS
Category	Earthen Levee			GPS Latitude/Longitude	
				Start	End
Item	Vegetation			39.439776 °	39.456841 °
				-121.641456 °	-121.639320 °
DWR ID	DWR_ST0005_01_s_ 2020_3				
Comment Code					
V1 : Control annual grass and weeds on the levee slopes and easements.					
Inspector Comment					
The annual vegetation is well maintained in this section, Spring 2020.

View looking upstream landside at the well maintained annual vegetation, Spring 2020.

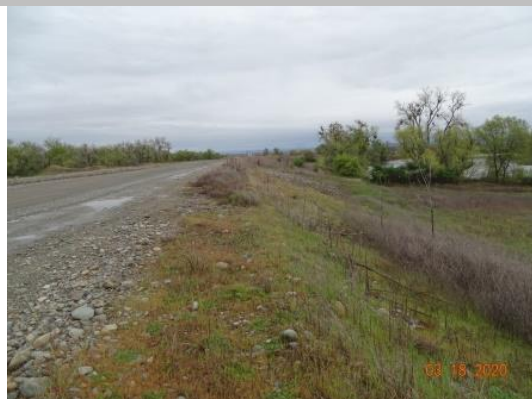
Photo 1 of 1 : SP\_2020\_ST0005\_289\_5\_20200327\_00013.jpg

LM Start	0.01	Rating **	A	Issue No.	5
LM End	1.22	Issue Type +	Ma	Location *	WS
Category	Earthen Levee			GPS Latitude/Longitude	
				Start	End
Item	Vegetation			39.439776 °	39.456842 °
				-121.641457 °	-121.639320 °
DWR ID	DWR_ST0005_01_s_ 2020_5				
Comment Code					
V1 : Control annual grass and weeds on the levee slopes and easements.					
Inspector Comment					
The annual vegetation is well maintained in this section, Spring 2020.

View looking upstream waterside at the well maintained annual vegetation, Spring 2020.

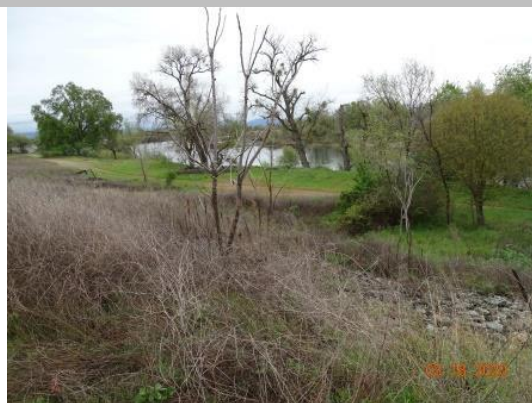
Photo 1 of 1 : SP\_2020\_ST0005\_289\_12\_20200327\_00014.jpg

LM Start	0.71	Rating **	M	Issue No.	12
LM End	0.91	Issue Type +	Ma	Location *	WS
Category	Earthen Levee			GPS Latitude/Longitude	
				Start	End
Item	Trim / Thin Trees			39.449757 °	39.452614 °
				-121.640886 °	-121.640284 °
DWR ID	DWR_ST0005_01_s_2020_12				
Comment Code					
T3 : Trim and thin trees to allow visibility of the ground and room to flood fight.					
Inspector Comment					
Trees that are less than 4" in diameter need to be removed, Spring 2020.

View looking upstream waterside at trees that are less than 4" in diameter that need to be removed, Spring 2020.

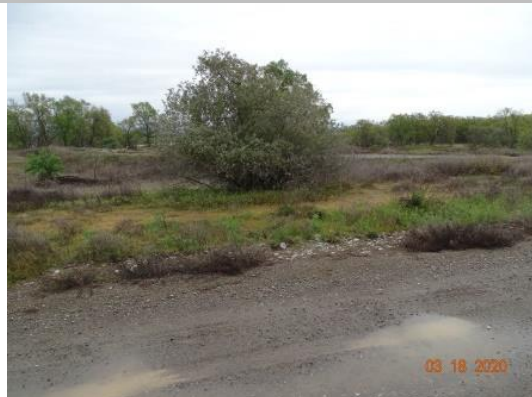
Photo 1 of 1 : SP\_2020\_ST0005\_289\_10\_20200327\_00015.jpg

LM Start	0.97	Rating **	M	Issue No.	10
LM End	0.97	Issue Type +	Ma	Location *	WS
Category	Earthen Levee			GPS Latitude/Longitude	
				Start	End
Item	Trim / Thin Trees			39.453512 °	39.453512 °
				-121.640272 °	-121.640272 °
DWR ID	DWR_ST0005_01_s _ 2020_10				
Comment Code					
T2 : Thin trees to allow visibility of the ground and room to flood fight.					
Inspector Comment					
Trim tree for visibility, Spring 2020.

View looking waterside at a tree hat needs to be trimmed for visibility, Spring 2020.

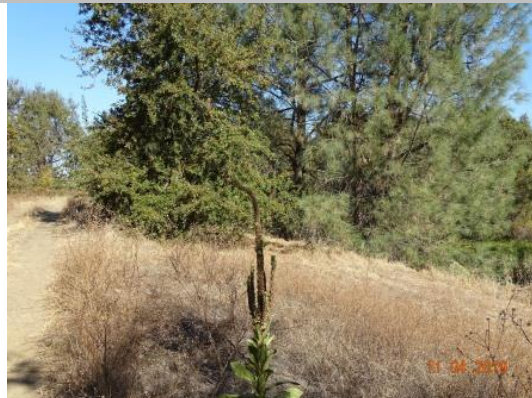
Photo 1 of 1 : SP\_2020\_ST0005\_289\_18\_20200227\_00005.jpg

LM Start	1.48	Rating **	U	Issue No.	18
LM End	1.99	Issue Type +	Ma	Location *	WS
Category	Earthen Levee			GPS Latitude/Longitude	
				Start	End
Item	Trim / Thin Trees			39.458053 °	39.461949 °
				-121.636300 °	-121.629563 °
DWR ID	DWR_ST0005_01_s_2017_18				
Comment Code					
T3 : Trim and thin trees to allow visibility of the ground and room to flood fight.					
Inspector Comment					
Trim/Thin Trees from Levee Mile 1.48 to 1.99. The LMA does not maintain the levee from Levee Mile 1.38 to 3.39.

View looking upstream of thick trees and vegetation blocking visibility on waterside.

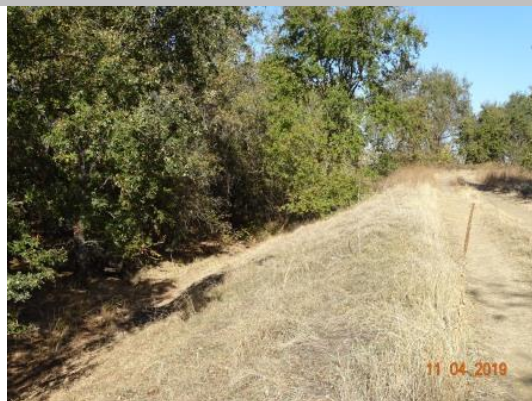
Photo 1 of 1 : SP\_2020\_ST0005\_289\_11\_20200227\_00003.jpg

LM Start	1.48	Rating **	U	Issue No.	11
LM End	3.25	Issue Type +	Ma	Location *	LS
Category	Earthen Levee			GPS Latitude/Longitude	
				Start	End
Item	Trim / Thin Trees			39.458055 °	39.470312 °
				-121.636300 °	-121.609242 °
DWR ID	DWR_ST0005_01_s_2017_11				
Comment Code					
T3 : Trim and thin trees to allow visibility of the ground and room to flood fight.					
Inspector Comment					
Trim/Thin Trees from Levee Mile 1.48 to 3.25. The LMA does not maintain the levee from Levee Mile 1.38 to 3.39.

View looking upstream of thick trees blocking visibility on landside.

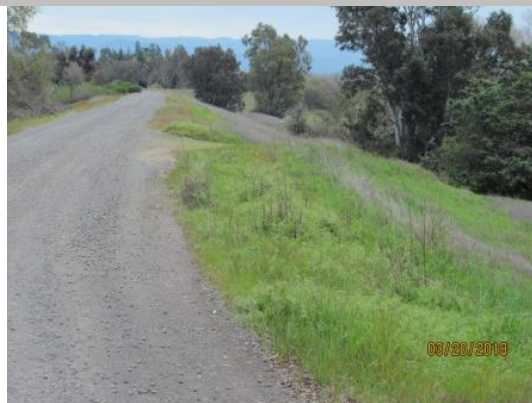
Photo 1 of 1 : SP\_2020\_ST0005\_289\_17\_20200227\_00004.jpg

LM Start	1.50	Rating **	U	Issue No.	17
LM End	1.96	Issue Type +	Ma	Location *	WS
Category	Earthen Levee			GPS Latitude/Longitude	
				Start	End
Item	Vegetation			39.458131 °	39.461634 °
				-121.635916 °	-121.629926 °
DWR ID	DWR_ST0005_01_f_2017_17				
Comment Code					
V2 : Remove the wild growth other than native grasses from the levee slopes.					
Inspector Comment					
Maintain annual grasses from Levee Mile 1.50 to 1.96. The LMA does not maintain the levee from Levee Mile 1.38 to 3.39.

View looking upstream waterside of annual grasses that need to be maintained.

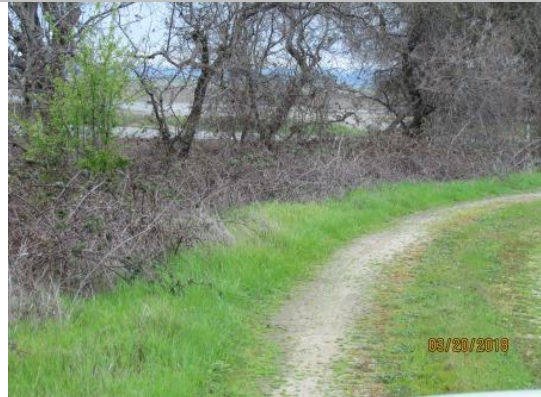
Photo 1 of 1 : SP\_2020\_ST0005\_289\_6\_20200227\_00002.jpg

LM Start	1.50	Rating **	U	Issue No.	6
LM End	2.63	Issue Type +	Ma	Location *	LS
Category	Earthen Levee			GPS Latitude/Longitude	
				Start	End
Item	Vegetation			39.458132 °	39.466025 °
				-121.635914 °	-121.618972 °
DWR ID	DWR_ST0005_01_f_2016_6				
Comment Code					
V2 : Remove the wild growth other than native grasses from the levee slopes.					
Inspector Comment					
Blackberries covering slope from Levee Mile 1.50 to 2.63. The LMA does not maintain the levee from Levee Mile 1.38 to 3.39.

View looking upstream landside of blackberries that are covering the landside slope.

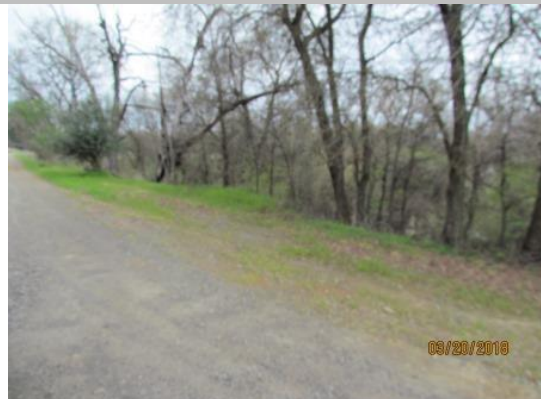
Photo 1 of 1 : SP\_2020\_ST0005\_289\_4\_20200227\_00001.jpg

LM Start	3.23	Rating **	U	Issue No.	4
LM End	3.27	Issue Type +	Ma	Location *	WS
Category	Earthen Levee			GPS Latitude/Longitude	
				Start	End
Item	Trim / Thin Trees			39.470063 °	39.470558 °
				-121.609264 °	-121.609215 °
DWR ID	DWR_ST0005_01_s_2013_4				
Comment Code					
T3 : Trim and thin trees to allow visibility of the ground and room to flood fight.					
Inspector Comment					
Small trees 4" in diameter at chest height should be removed before they get too big from Levee Mile 3.23 to 3.27. Levee Mile 1.38 to 3.39 has never been maintained by the LMA.

View looking upstream waterside of small trees 4" in diameter at chest height should be removed before they get too big.

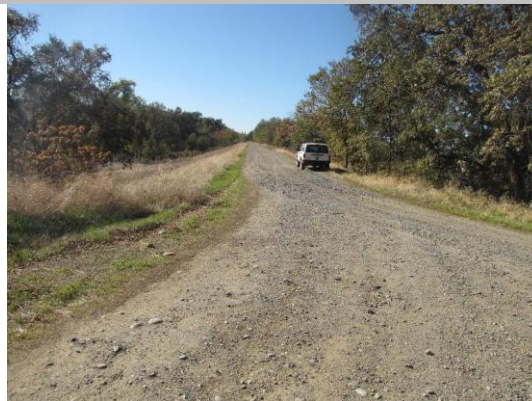
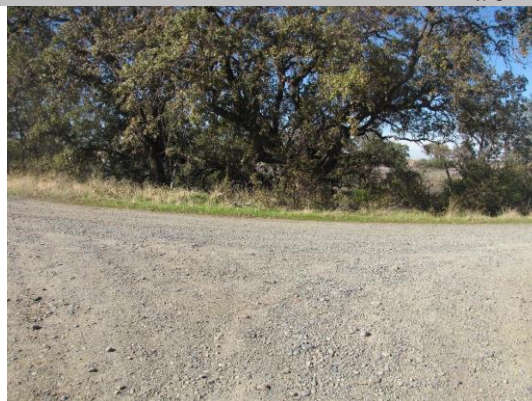
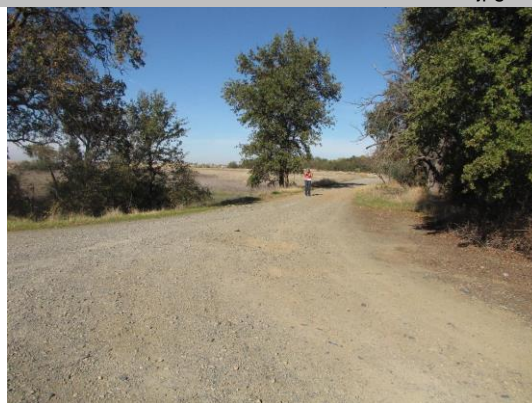
DS\_ID:17056  
FS\_ID:55889  
EP\_NO: N/A  
Repair Type: Non-Urgent  
Crossing Status: Indicator Found  
UCIP Comments: 05/07/2019 Limited access--Unable to inspect crossing due to steep slopes and dense vegetation. (O. Magana - DWR UCIP)04/26/2016 Unable to access area near structure.05/14/2013 Same as last inspection.11/14/2012 Abandoned Structure: WS-remance of gates and concrete standpipe; LS-remance of concrete headwall and pump station.  
FIELD\_STRUCT\_DESC: \*ABANDONED\* [Western Canal Head Gate Inlet Structure] 2 of 2: 72-inch by 96-inch (8-foot by 8-foot) reinforced concrete culvert through the levee 25 feet below the crown. Three slide gates on the waterside (WS) end. Concrete stairs on the WS slope. Concrete headwall at both WS and landside (LS) toes. [Additional Reference(s): DWR Levee Log, 2005. USACE Sacramento O&M Manual 152, March 1957 (Station 170+00)]  
FS Date: 5/7/2019 12:37:00 PM
